Kenya Water Towers Status Report **Namanga Hill**

Coordinated Water Towers Conservation
2018 - 2019 (1st Quarter)

Kenya Water Towers Status Report

for
Namanga Hill

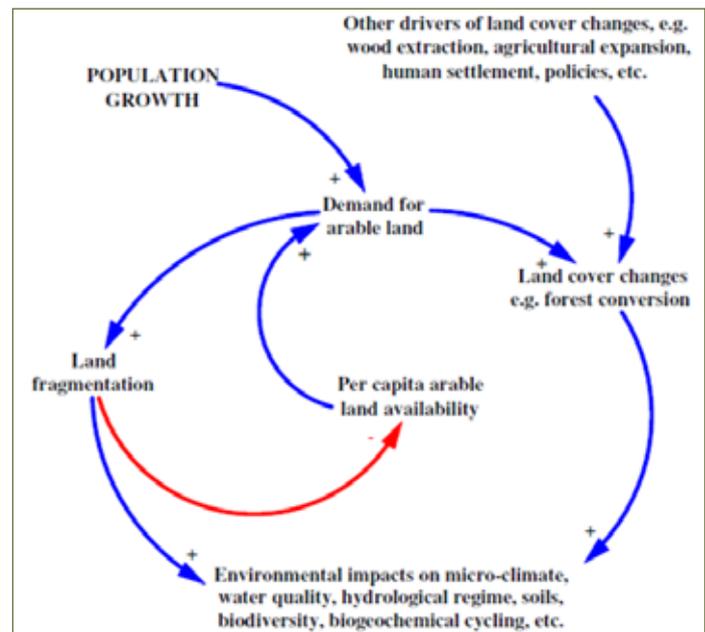
Figure 1.2: Causal Loop Diagram Illustrating Threats Facing the Water Tower. Note: The positive (+) sign denotes an increasing effect while the negative (-) sign denotes a decreasing effect

Protection and conservation of these important ecosystems continues to face a number of challenges. Rapid population growth whose spiral effects include increased land fragmentation, encroachment and over exploitation of natural resources within the water towers ecosystems. These have resulted to adverse environmental impacts such as drying up of rivers, dams and springs; loss of biodiversity and changes in micro-climatic conditions (Figure 1.2).

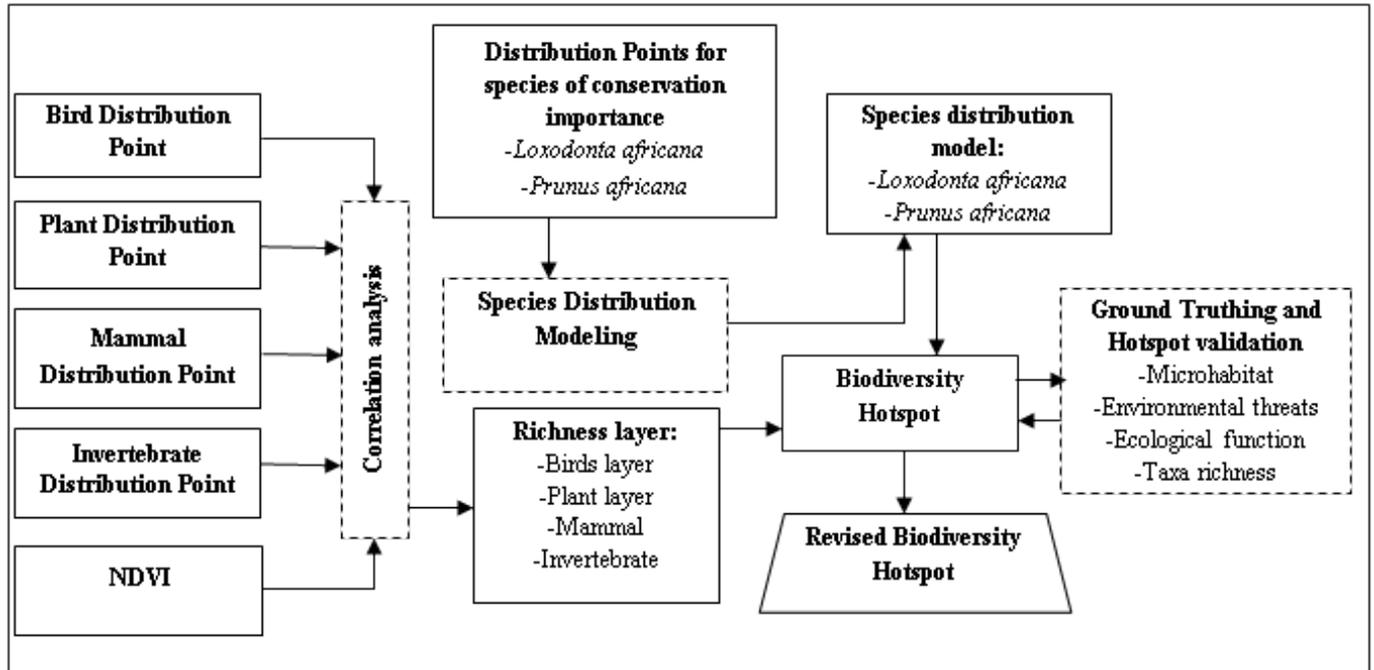
Figure 1.3: Datasets and process of mapping Biodiversity hotspot areas in the Water Towers

Field validation was conducted to confirm hotspot index generated during desktop work using variables listed for assessment. The

process and datasets used in analyzing hotspots areas are summarized in Figure 1.3 below.

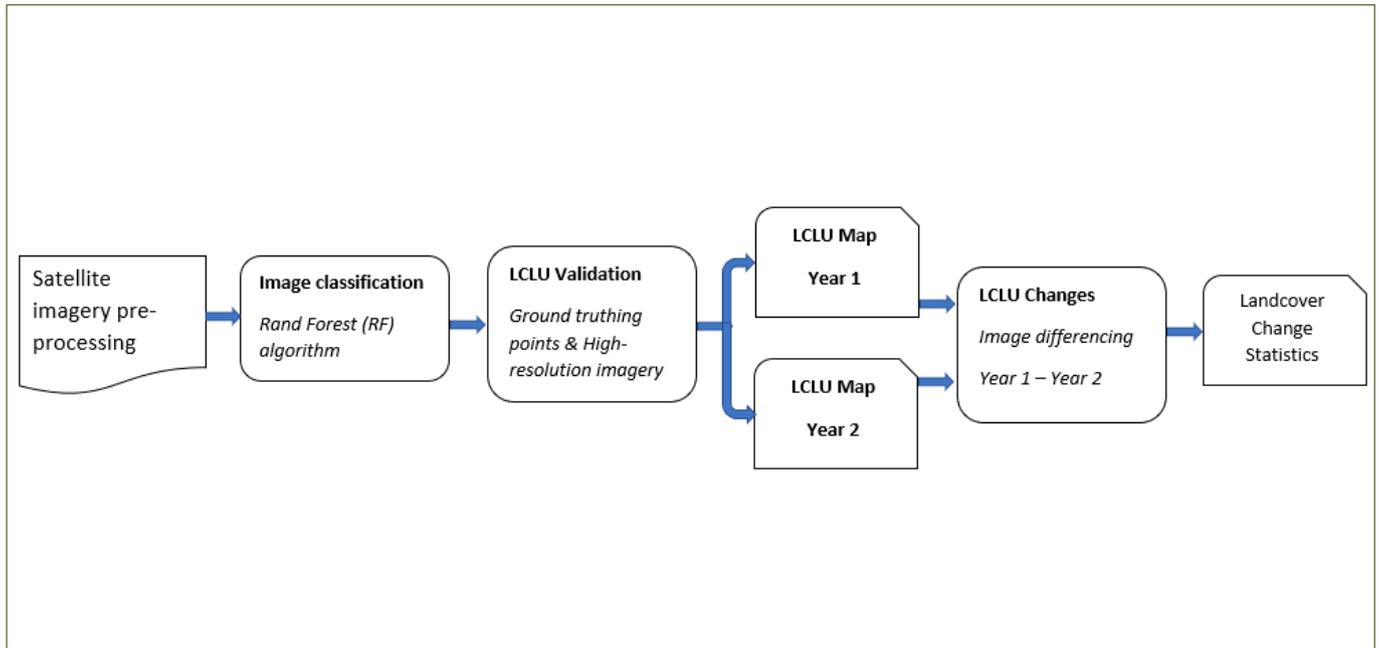
Figure 1.4: Process of mapping land cover and land use in the Water Tower

Multiple analytical methods were used to study and interpret Land Cover and Land Use (LCLU) changes and explore the drivers and socio-economic impacts over time and space. Geographic Information System (GIS) and Remote Sensing (RS) techniques were used to carry out LCLU assessment (Figure 1.3). Classified LCLU from the satellite imagery using Random forest classifier were validated using ground truthing points collected during fieldwork. The LCLU changes in the water towers were determined by undertaking image differencing of 1990 image with the latest classified image using ERDAS Imagine software and statistics tabulated as conversion matrix using Microsoft Excel.

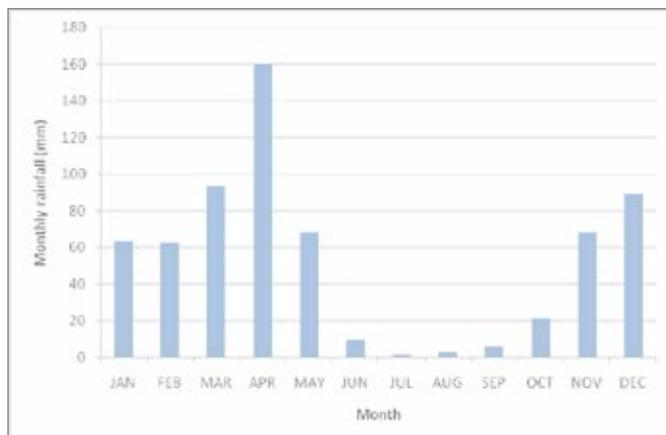
Figure 2.2: Monthly Rainfall Distribution in Namanga

Namanga Hill Water Tower lies in the semi arid lands of Kenya categorised as Agro Ecological Zone V. The average temperature is 21°C with a maximum of about 23°C in March and a minimum of 18°C in July. The annual rainfall ranges between 300-800 mm with a bimodal distribution pattern, whereby short rains occur between October-December and long rains in March-May (Figure 2.2).

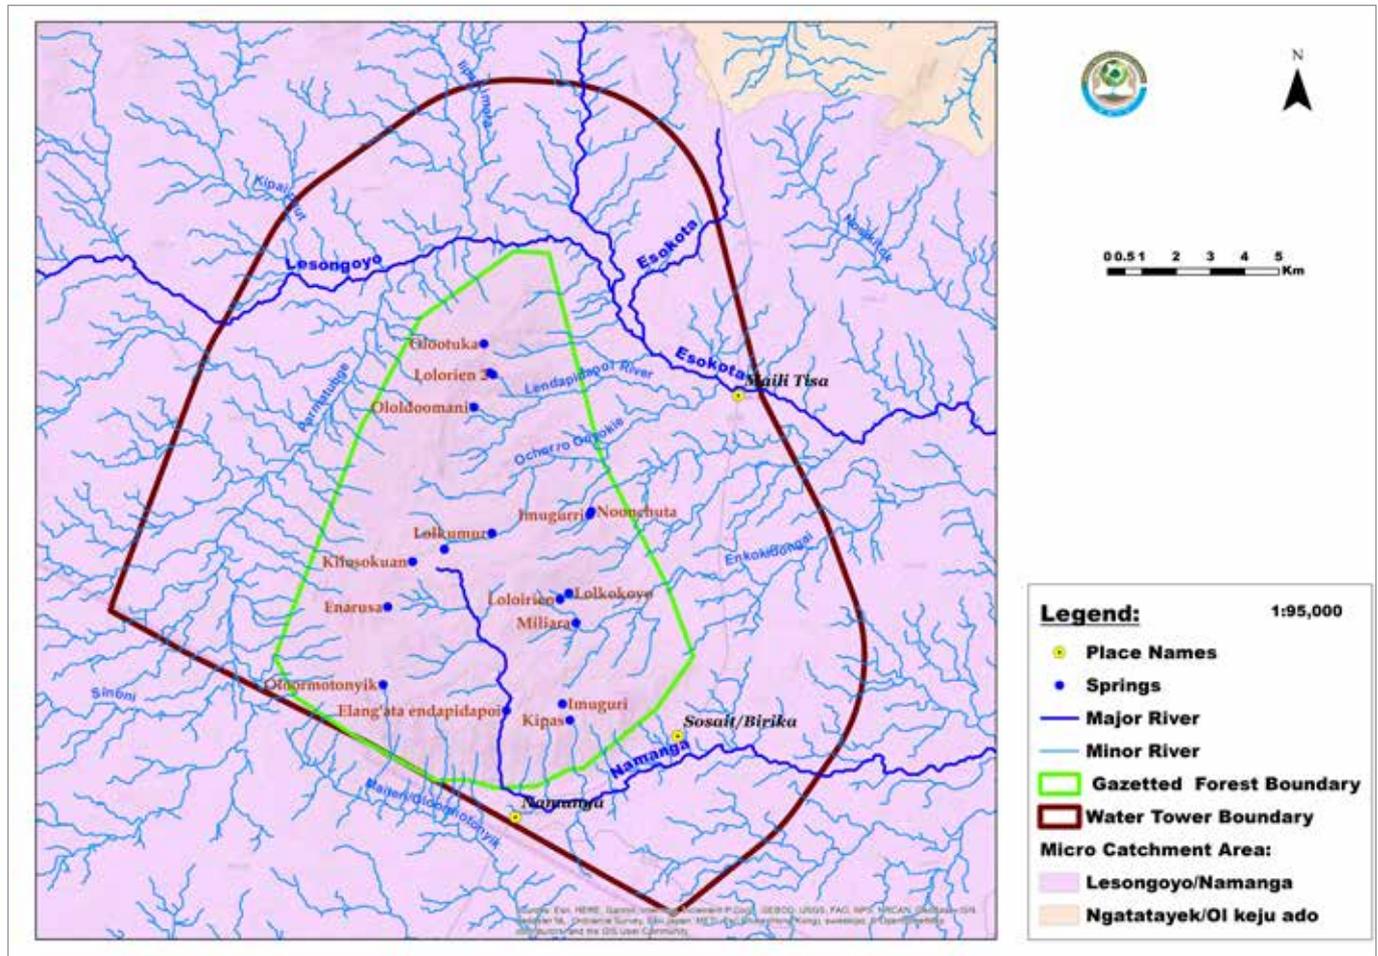
Figure 2.3: Spring and River Network in Namanga Hills Water Tower

The Water Tower has a total of 17 springs; all permanent and located within the gazetted forest (Table 2.1). However, the water volume reduces during the dry period.

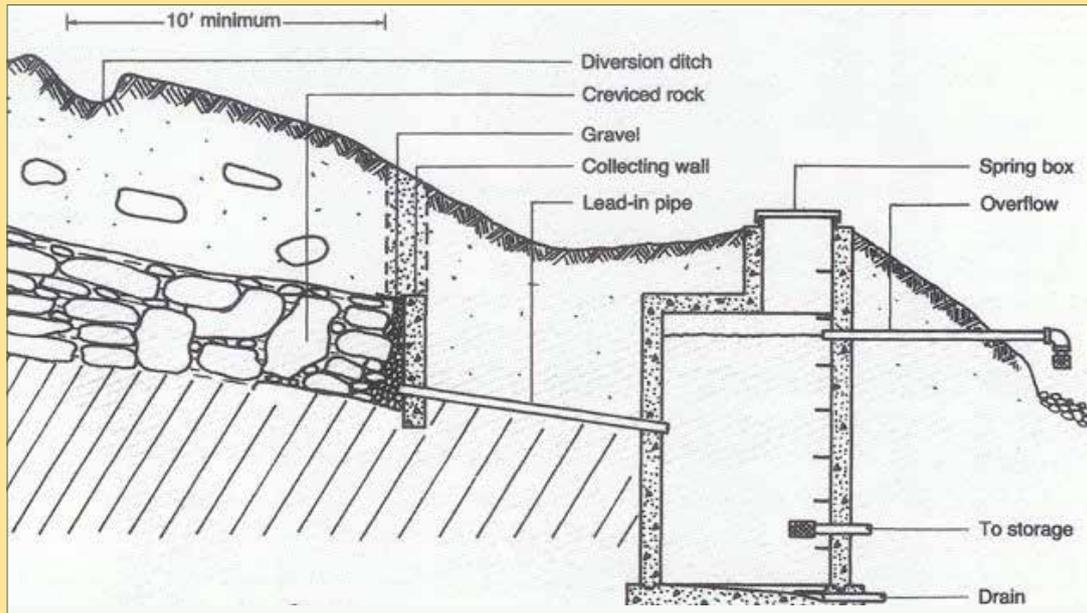
Figure 1: Development of a concentrated spring (Adapted from Safeguarding Wells and Springs from Bacterial Contamination, Department of Agricultural and Biological Engineering, The Pennsylvania State University)

Spring development involves protecting both the spring and its water quality from environmental damage and contamination, as well as improving access to the water. Before a spring is developed, it is essential to check the quantity and quality of the water. The rate of flow should be reliable through all seasons.

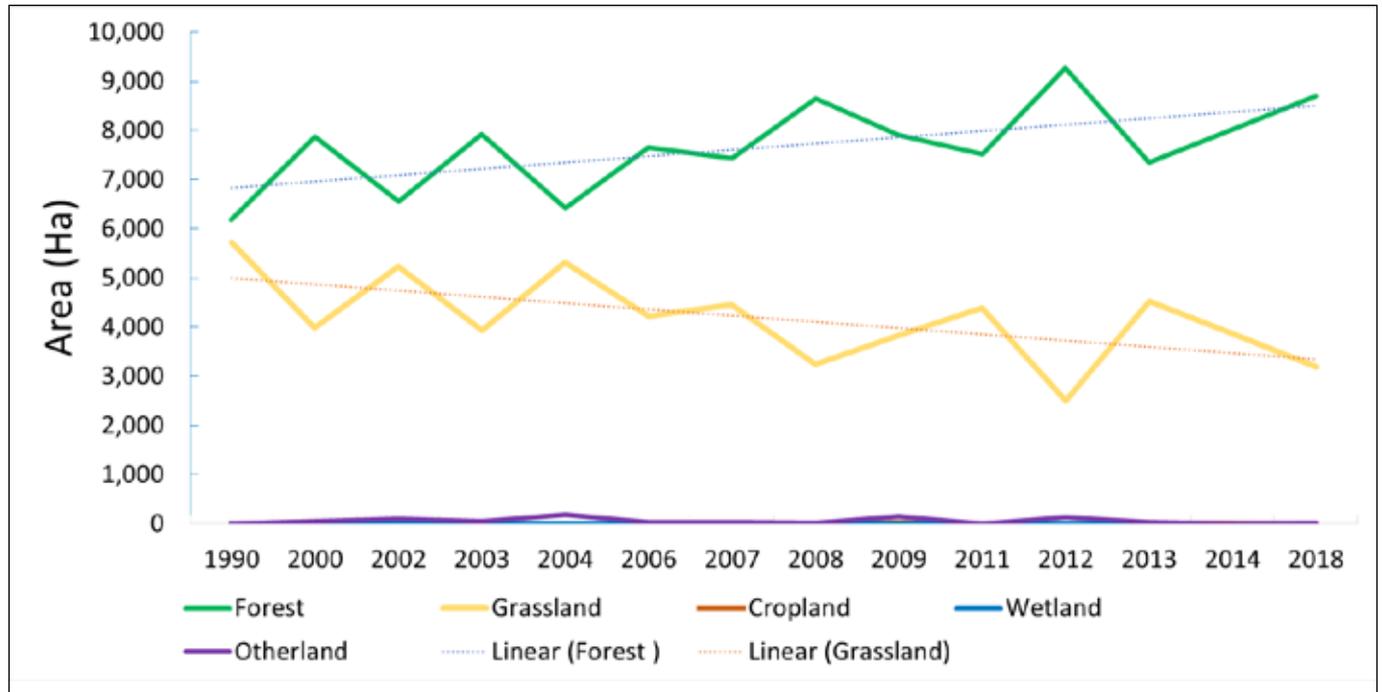
Figure 2.6: Land Use Land Cover Trends in the the gazetted forest

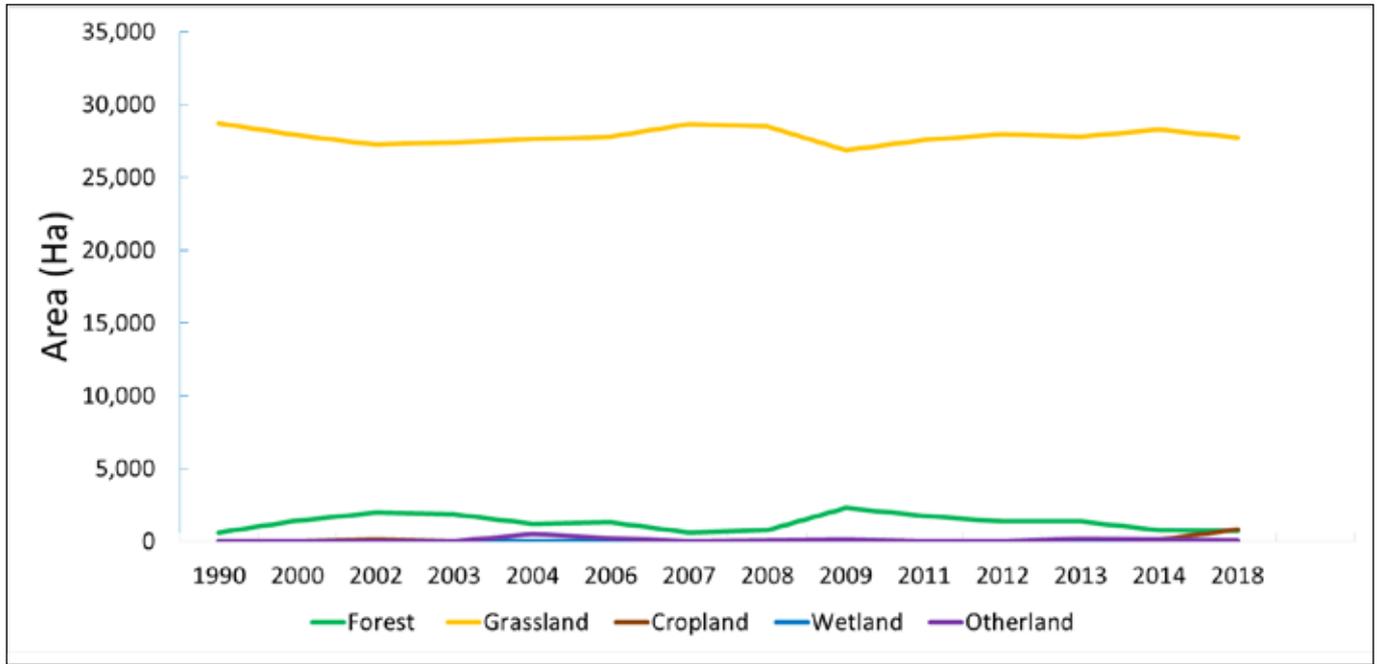
Figure 2.7: Trend for Forestland in the Buffer Zone of Namanga Hill.

By 2018, the forestland within the buffer zone had increased by 37.9 % (from 6,832 to 9,422 ha) while grassland declined by 10% (34,417 to 30,793 ha). The decline could be attributed to overgrazing and the condition has been exacerbated by the changing climatic conditions in area. (Figure 2.7; Figure 2.8; Figure 2.9).

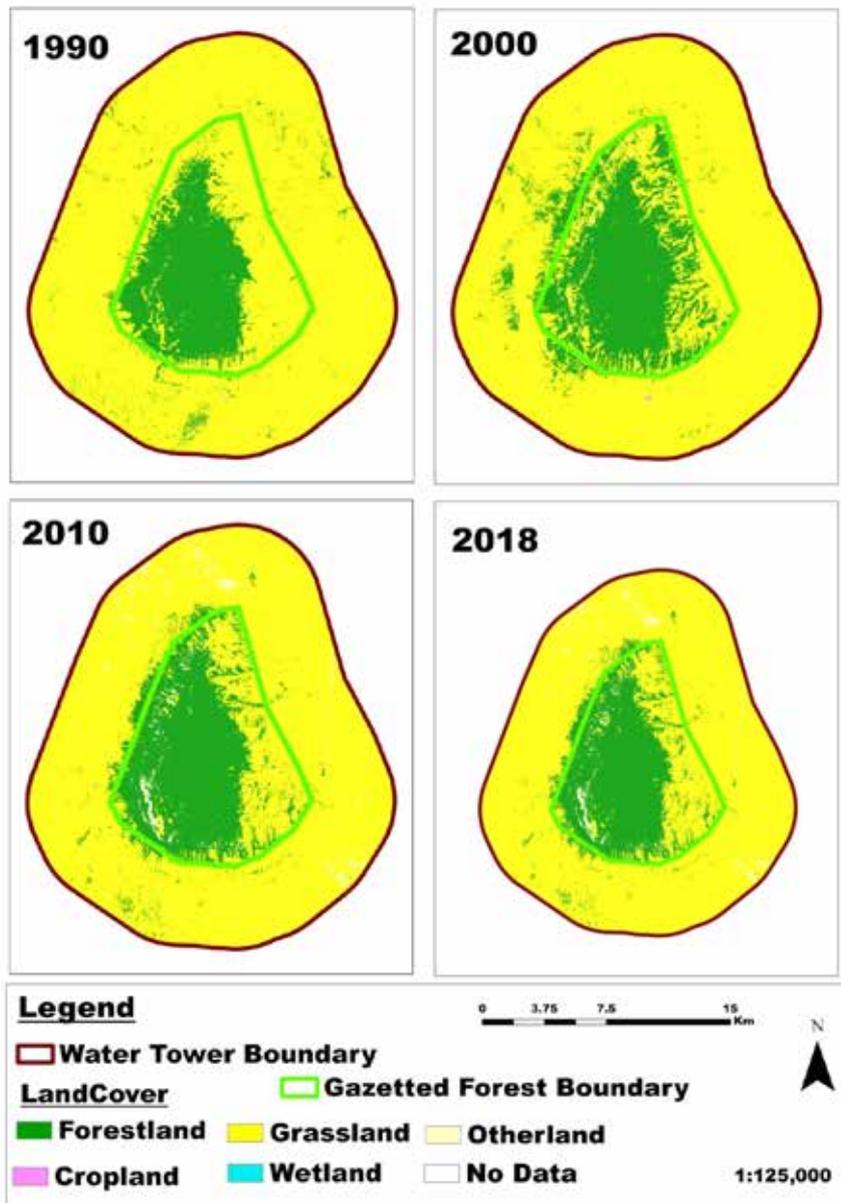
Figure 2.8: Namanga Hill Land Use Land Cover Trends between 1990-2018

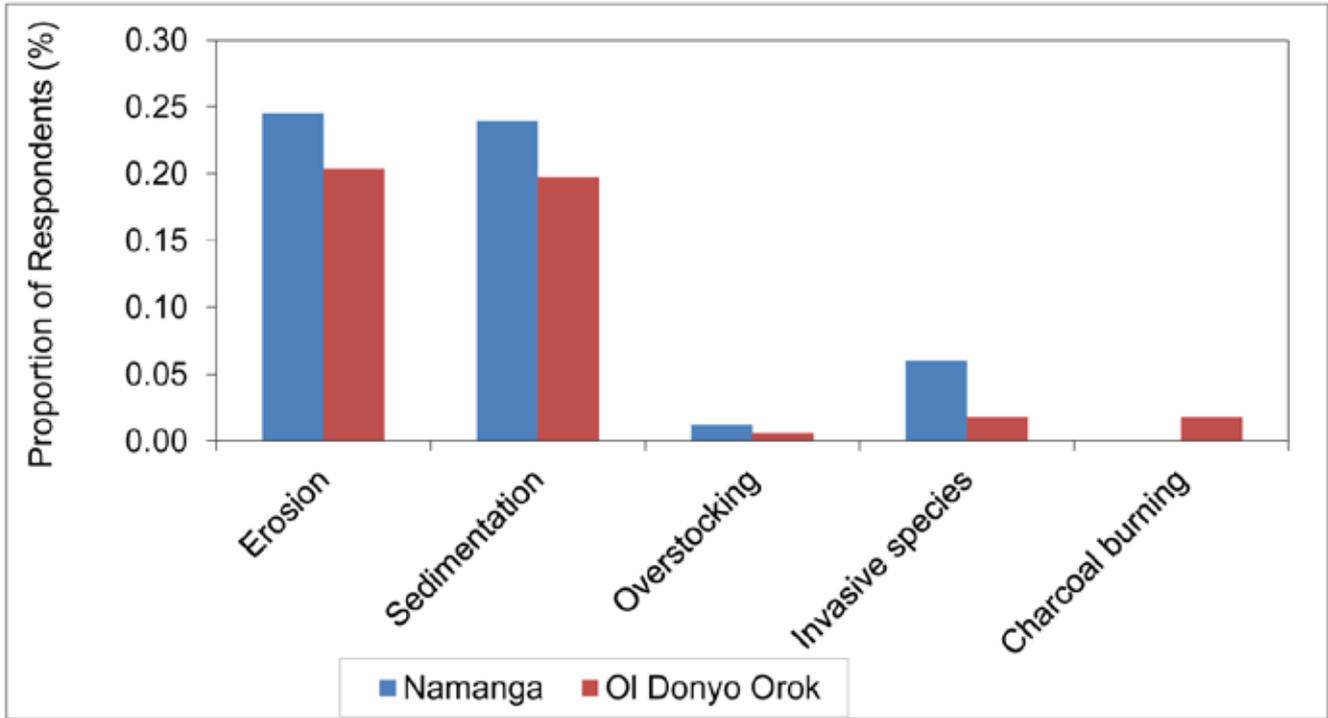
Figure 2.9: Drivers of Degradation in Namanga Hills Water Tower

The main causal factors for degradation were erosion and sedimentation (Figure 2.10) leading to development of gullies (Plate 2.2). Erosion had negatively affected soil productivity, restricted land use and destroyed infrastructure such as roads, fences and buildings. The Eastern and Southern sectors of the Water Tower recorded the highest density of active gullies (Figure 2.11).

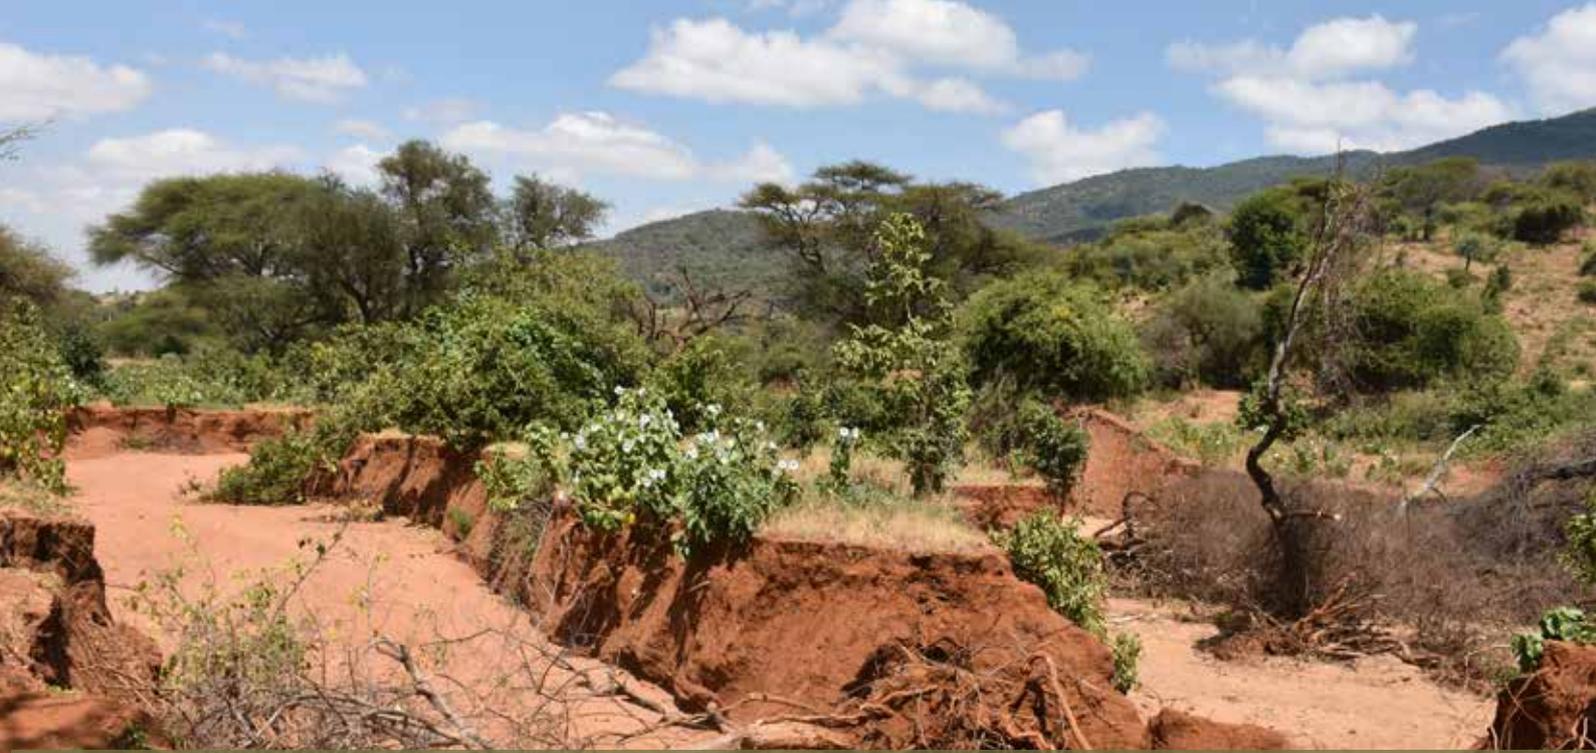
Plate 2.14: Gully Erosion in the Buffer Zone of Namanga Hill.

This is the major threat being experienced in the Water Tower, especially on the Eastern and Southern side. This form of degradation is manifested through development of large gulleys that has affected soil productivity, restricted land use as well as threatening destruction of roads, fences and buildings. These gullies are as a result decreased or sparse land cover that will enhance soil resistance to erosion.

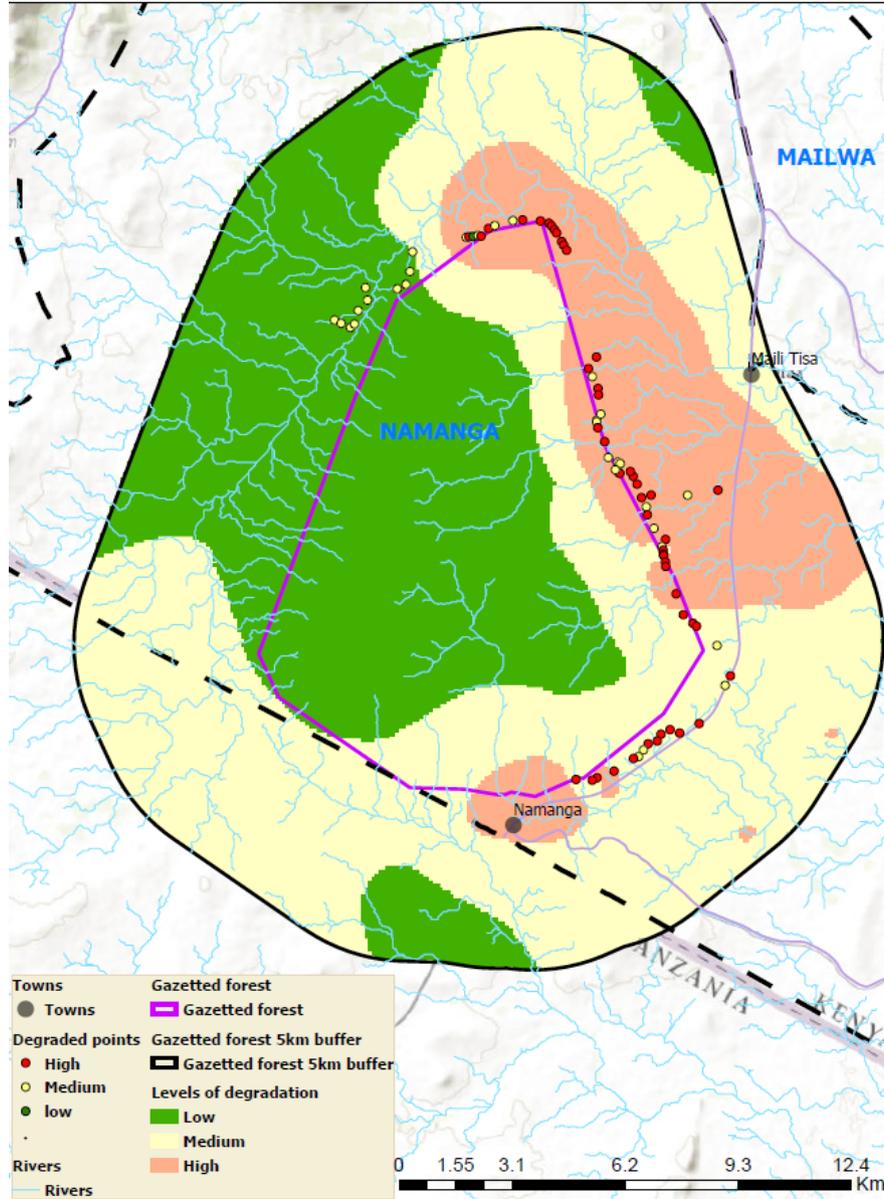
Figure 2.01: Map Showing Degradation Levels in Namanga Hill.

The highest level of degradation in Namanga Hill Water Tower was categorised as high, medium and low based on visual observation with the highest level of of degradation observed at 60.3 %, Medium (38.5%) and low (1.3%).
